STOL CH 801 WING ASSEMBLY

SECTION 6

“INSTALLING THE BOTTOM REAR WING SKINS”

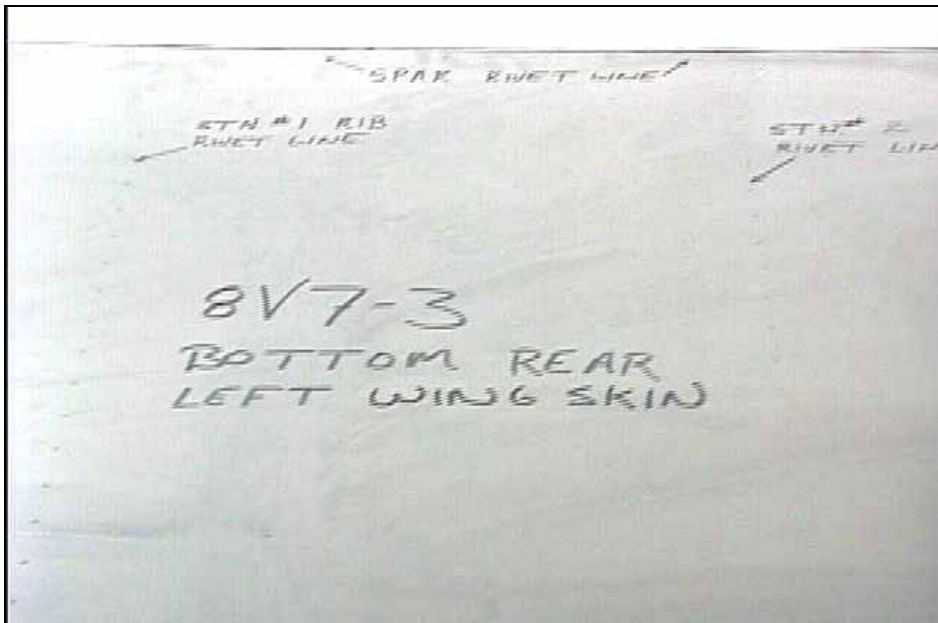
Photo V6-1

The bottom rear skin 8V7-3 is made in two pieces identified as bottom rear I/B skin and bottom rear O/B skin.

Skin 8V7-3 I/B covers the area from rib to rib to station #6.

It will be the first skin to be installed.

The wing skin is interchangeable left wing or right wing.

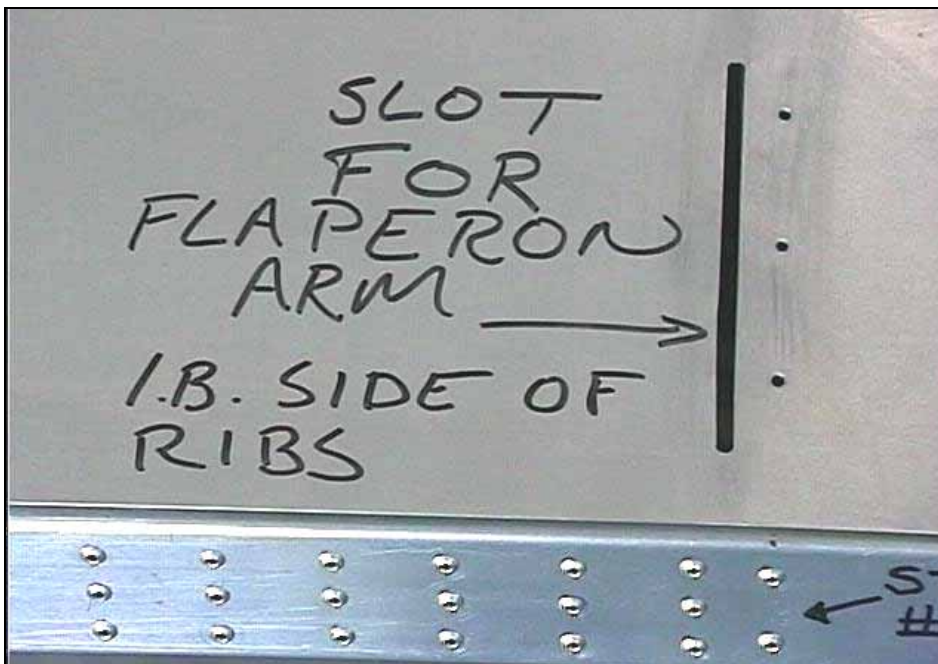
Photo V6-2

The slots for the flaperon arms are precut at the factory.

Check the position of the flaperon slot and rib. The correct location here will confirm the orientation of the skin.

Cleco a flaperon arm in place. It will help confirm your positioning of the skin.

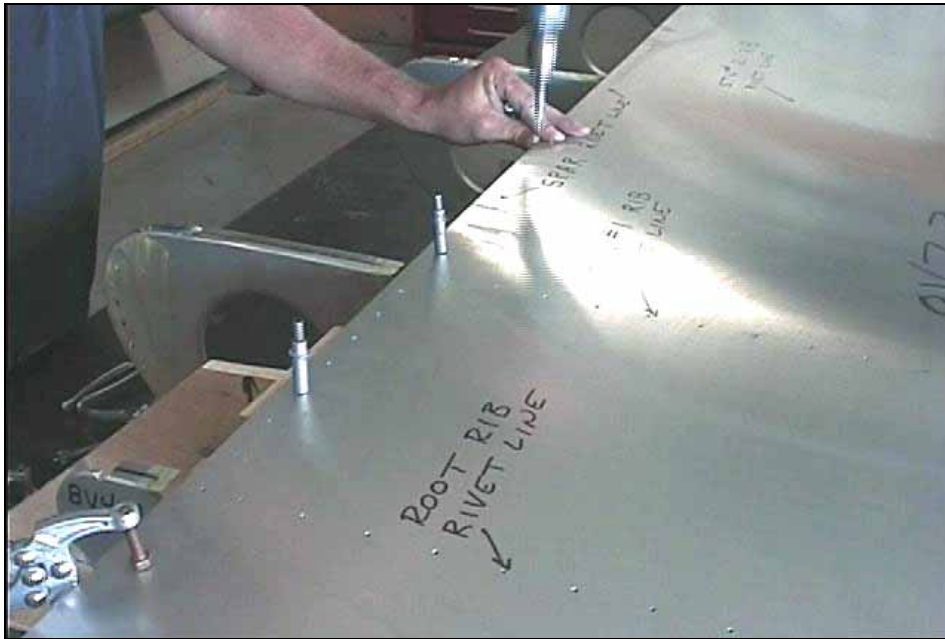
Photo V6-3

Check alignment on all rib rivet lines.
 Consider the skin edges and the centers of the predrilled holes to be a giant square which will true up the skeleton.

The operative word here is "check". Time spent now confirming the skin is in the correct position prior to doing any drilling will result in a superior finished product

Position the skin with its front edge flush with the forward edge of the spar and the predrilled rib holes lined up with the rib flange centerlines. Slide the skin sideways until the rib centerlines line up along their entire length.

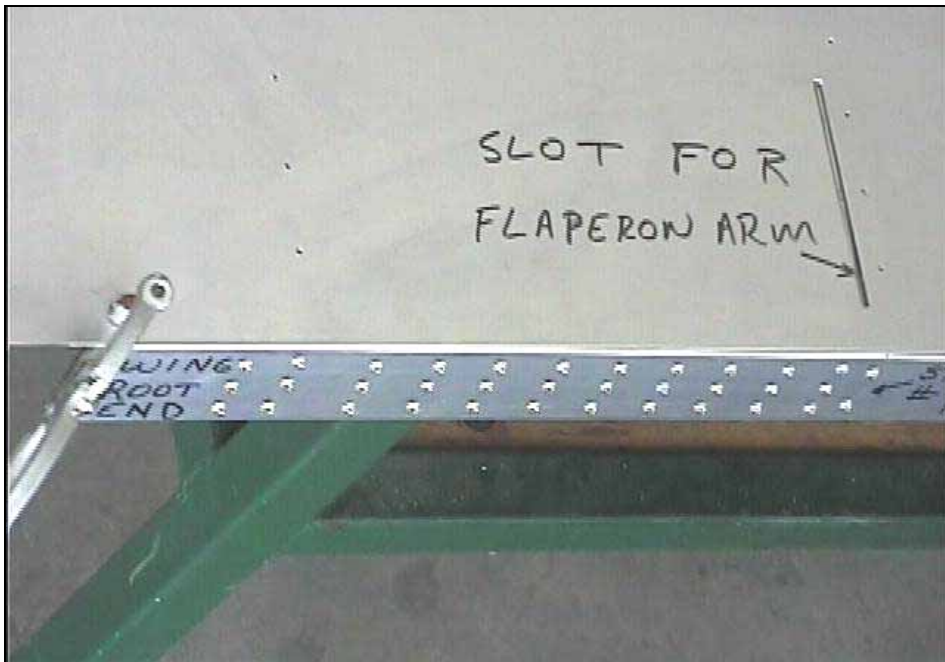
Photo V6-4

When the alignment is correct, clamp the skin at its four corners.
 - Re check alignment of the rib flange center lines to the predrilled holes.
 Drill and cleco the main spar line rivet holes - every 8 or 10th hole only, at this time. Use a 3/32 drill. Do not drill any holes in the rear spar.

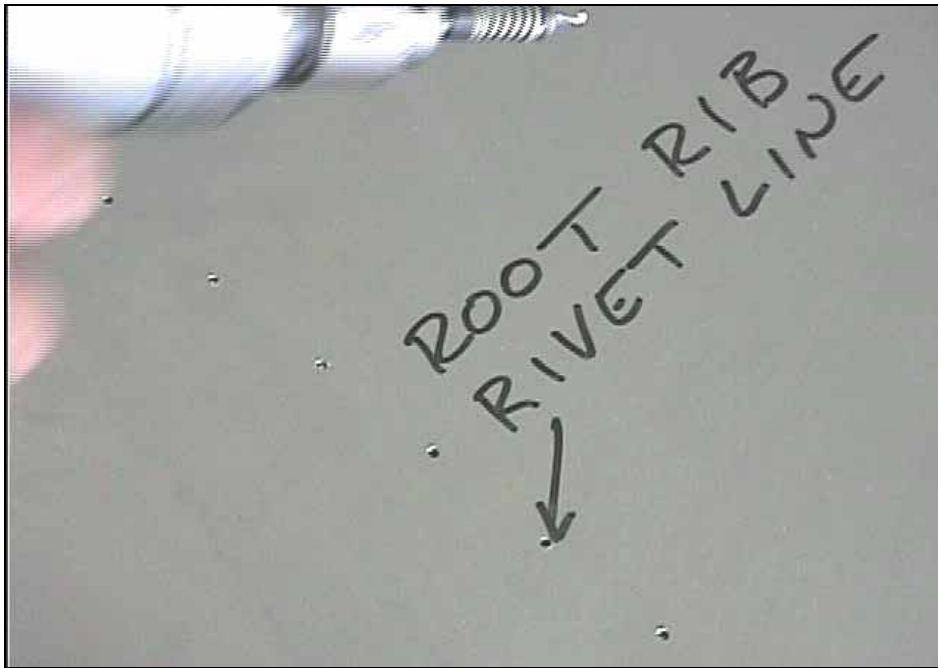
Photo V6-5

Keeping a close eye on the center lines and clecoing well as you drill will ensure good results.

All the rib rivet holes may be drilled at this time, using a 3/32" drill bit.

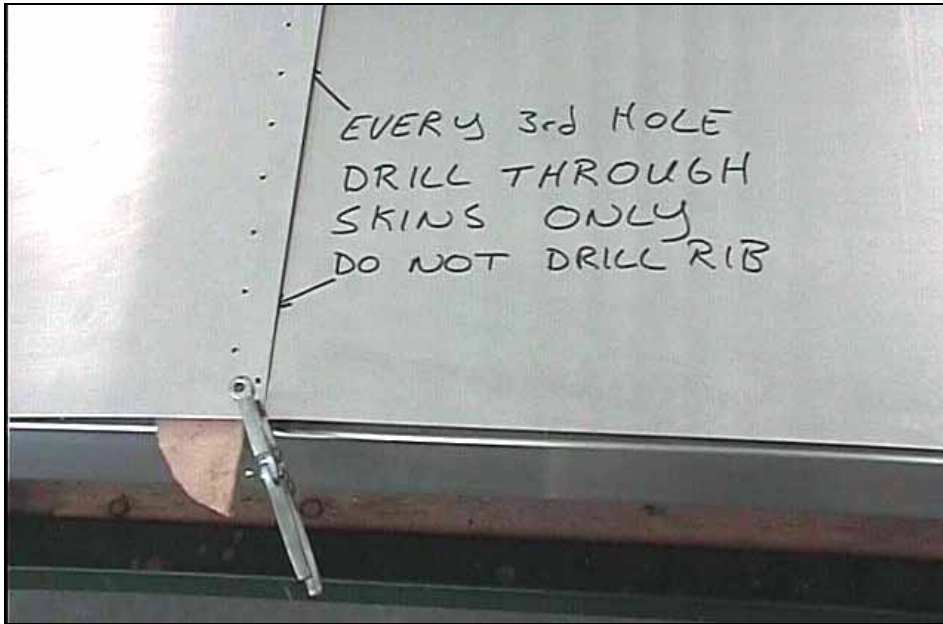
Photo V6-7

Cleco as drilling proceeds.

Align 8V7-3 O/B with the previously installed portion of 8V7-3 I/B, the forward edge of the main spar and rib #7's flange centerline with the predrilled holes in the skin.

Slide a thin piece of wood under the skins and drill every 3rd hole. Do not drill into the rib.

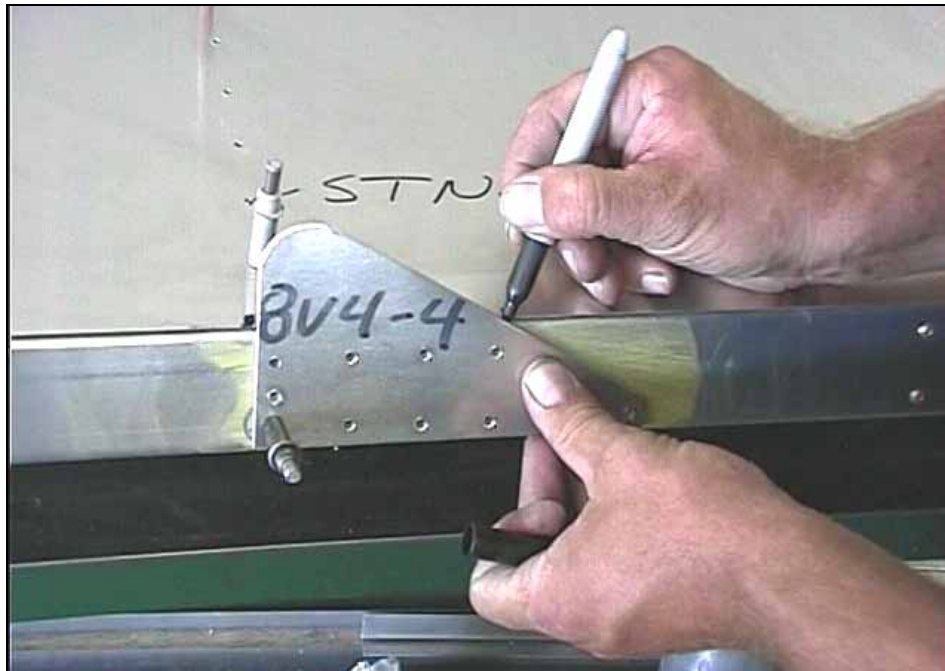
Photo V6-10

Cleco 8V4-4 in place and mark where it intersects with the skin, on the skin.

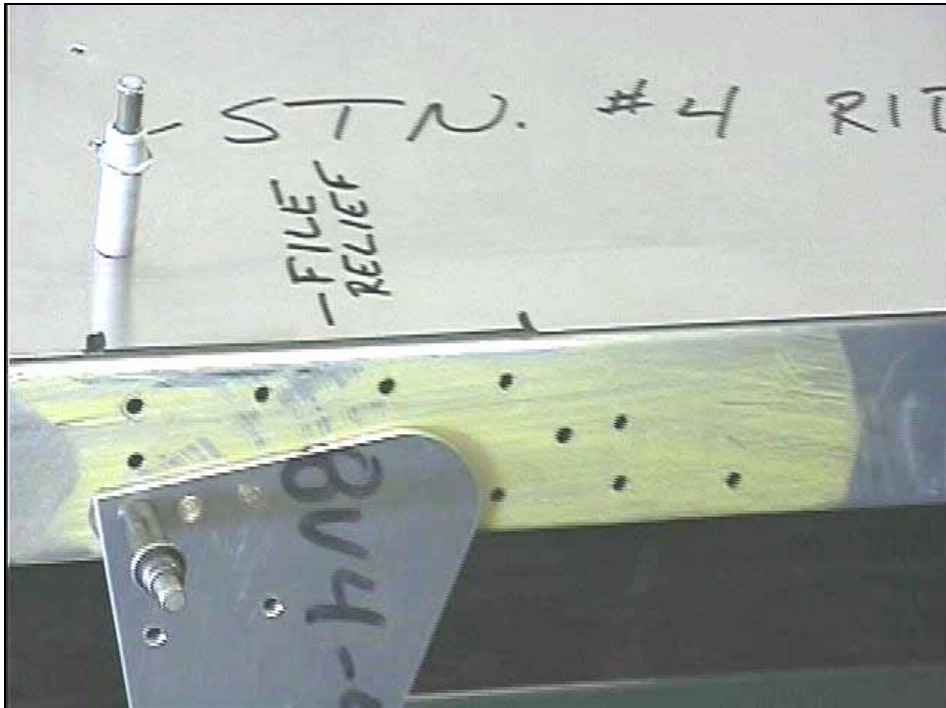
Photo V6-11

Do not rivet 8V4-4 in place at this time.

A 1mm - 2mm relief is to be filed in the skin to clear 8V4-4.

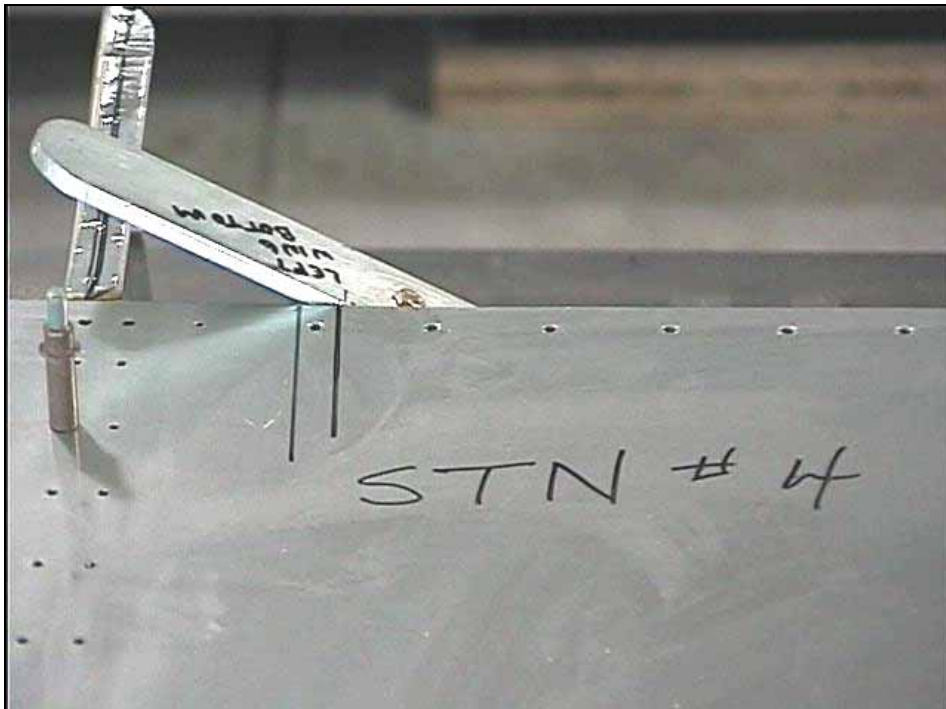
Photo V6-12

Extend lines from the strut pickup onto the rear skin. These reference lines are required later when installing the leading edge skin.

Remove the two skins and deburr all holes. Re-cleco the skins in position. Place and pull rivets in all the holes which have been opened to #30 drill size except for the six holes in each rib closest to the main spar.
