STOL CH 801	ORIGINAL INFO MJM 07/15/02 REVISION INFO	DESCRIPTION	ASSY NO.
		FUSELAGE CONTROLS: RUDDER CABLES	8CF-6
		COPYRIGHT © 2002 ZENITH AIRCRAFT CO. WWW.ZENITHAIR.COM

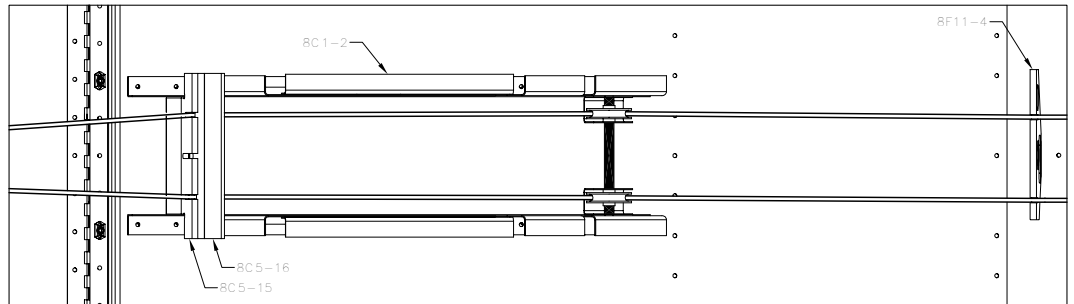
THE PULLEYS HELP MAINTAIN A STRAIGHT LINE BETWEEN BEARING 8F11-4 AND BEARING 8C15-5
